**Flood Control Project Maintenance  
Levee Inspections**  
**LMA District Cover Sheet**  
**Spring 2018 Levee Inspection Results**

**Reclamation District No. 2064 River Junction**

**Levee Inspection Report By Mile - Spring 2018**

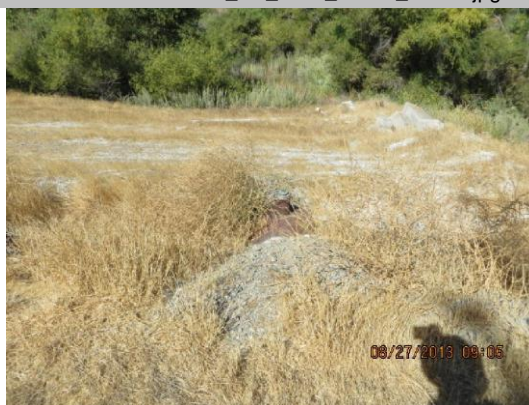
Photo 2 of 3 : UCIP\_SP\_2018\_22729\_38457.jpg

LM Start	0.06	Rating **	M	Issue No.	33
LM End	0.06	Issue Type +	En	Location *	
Category	Supplemental			GPS Latitude/Longitude	
				Start	End
Item	DWR UCIP Field Study			37.709698 °	37.709698 °
				-121.267536 °	-121.267536 °
DWR ID					
Comment Code					
Inspector Comment					
FS_ID:22729 DS_ID:20527 EP_NO: 13907 Repair Type: Non-Urgent Crossing Status: Found UCIP Comments: This pipe has less than 1-foot of cover. FIELD_STRUCT_DESC: 2 of 3: 24-inch coated steel drainage discharge pipe through the levee, 2 feet below the crown. Two 100-horsepower and one 75-horsepower pumps on pier at the landside (LS) toe. Siphon breaker on the waterside (WS) shoulder. (Permit No. 13907, 1985 - Reclamation District No. 2064). [Additional Reference(s): DWR Levee Log, 2005]. FS Date: 8/27/2013

Pipe and siphon breaker on WS shoulder.

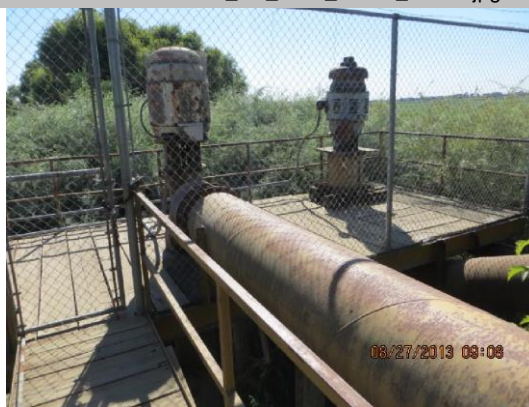
Photo 3 of 3 : UCIP\_SP\_2018\_18720\_31292.jpg

Pump on pier on LS.

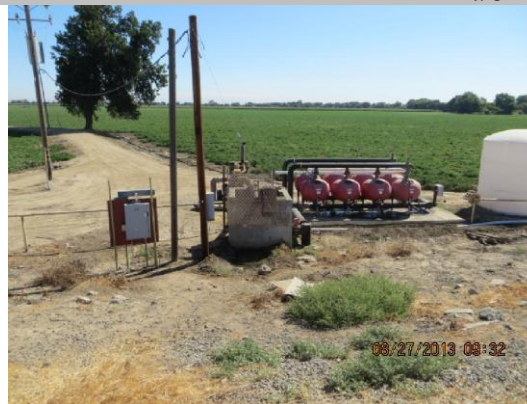
Photo 2 of 3 : UCIP\_SP\_2018\_40792\_31376.jpg

Comment Code					
Inspector Comment					
FS_ID:40792 DS_ID:20533 EP_NO: N/A Repair Type: Non-Urgent Crossing Status: Found UCIP Comments: Pump and slant pipe missing from structure on WS slope. FIELD_STRUCT_DESC: 12-inch concrete encased steel irrigation pipe through the levee, 13 feet below the crown. Slant pump on the waterside (WS) toe. Slide gate in a 36-inch corrugated metal pipe (CMP) riser on the WS shoulder. 6-foot by 6-foot concrete distribution box and filter plant on the landside (LS) toe. 2-inch galvanized iron electrical conduit at the same location. [Additional Reference(s): DWR Levee Log, 2005. USACE San Joaquin O&M Manual 3, December 1968, (HLM 1.24)]. FS Date: 8/27/2013

Concrete distribution box and filter plant on LS toe.

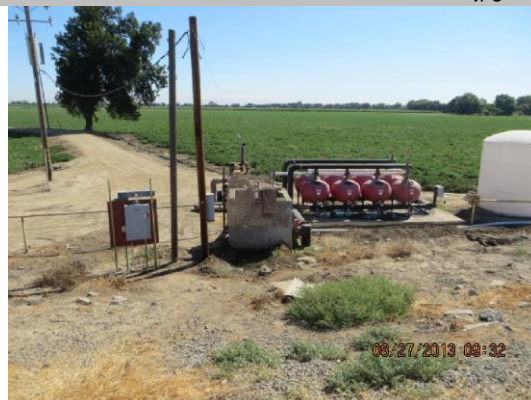
Photo 2 of 3 : UCIP\_SP\_2018\_51638\_38461.jpg

Comment Code					
Inspector Comment					
FS_ID:51638 DS_ID:20524 EP_NO: 3739 Repair Type: Urgent Crossing Status: Found UCIP Comments: 11/16/2016 same as last inspection leak has created sink hole near concrete distribution box located on the LS. Hole in pipe is visible at sink hole. Need to contact owner to address leak on LS. Recommend an internal inspection be completed for the pipe through the levee to determine pipe integrity. (O. Magana - DWR UCIP)08/27/2013 Some leakage at connection between pipe and distro box on LS toe. This may indicate internal failure of pipe. (W. Wylie - DWR UCIP) FIELD_STRUCT_DESC: 16-inch coated steel irrigation pipe through the levee, 10.75 feet below the crown. 2-inch galvanized iron electrical conduit at the same location. Slant pump on the waterside (WS) toe. Slide gate in a 36-inch corrugated metal pipe (CMP) riser on the WS shoulder. 6-foot by 6-foot concrete distribution box and filter plant on the landside (LS) toe. (16-inch pipe authorized under Permit No. 3739, 1961 - Mortensen and Barker). FS Date: 11/16/2016

Concrete distribution box on LS toe with filter plant.

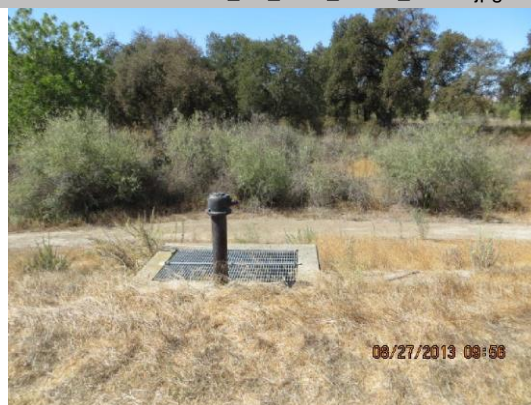
Photo 2 of 3 : UCIP\_SP\_2018\_18748\_31379.jpg

LM Start	1.65	Rating **	A/W	Issue No.	37
LM End	1.65	Issue Type +	Ma	Location *	
Category	Supplemental			GPS Latitude/Longitude	
				Start	End
Item	DWR UCIP LMA Responsibility			37.690072 °	37.690072 °
				-121.269823 °	-121.269823 °
DWR ID					
Comment Code					
Inspector Comment					
FS_ID:18748 DS_ID:20514 EP_NO: N/A Repair Type: No Action Needed Crossing Status: Found UCIP Comments: FIELD_STRUCT_DESC: 30-inch by 30-inch reinforced concrete box drainage culvert through the levee, 15 feet below the crown. Slide gate in a concrete riser on the waterside (WS) shoulder. Concrete U-shaped headwalls on both ends. Flap gate on the WS end. [Additional Reference(s): DWR Levee Log, 2005. USACE San Joaquin O&M Manual 3, December 1968, (HLM 1.65)]. FS Date: 8/27/2013

Slide gate in concrete vault on WS shoulder.

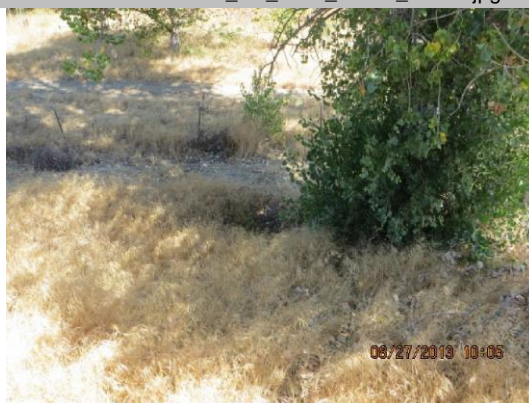
Photo 2 of 3 : UCIP\_SP\_2018\_18763\_31401.jpg

LM Start	1.94	Rating **	M	Issue No.	38 (cont)	
LM End	1.94	Issue Type +	Ma	Location *		
Category	Supplemental			GPS Latitude/Longitude		
				Start	End	
Item	DWR UCIP LMA Responsibility			37.689900 °	37.689900 °	
				-121.264802 °	-121.264802 °	
DWR ID						
Comment Code						
Inspector Comment						
FS_ID:18763 DS_ID:20515 EP_NO: N/A Repair Type: Non-Urgent Crossing Status: Found UCIP Comments: Culvert filled nearly to the top with soil. FIELD_STRUCT_DESC: 30-inch by 30-inch reinforced concrete box drainage culvert through the levee, 14.7 feet below the crown. Slide gate in a concrete riser on the waterside (WS) slope. Concrete U-shaped headwalls on both ends. Flap gate on the WS end. [Additional Reference(s): DWR Levee Log, 2005. USACE San Joaquin O&M Manual 3, December 1968, (HLM 1.93)]. FS Date: 8/27/2013

Concrete U-shaped headwall on LS toe.

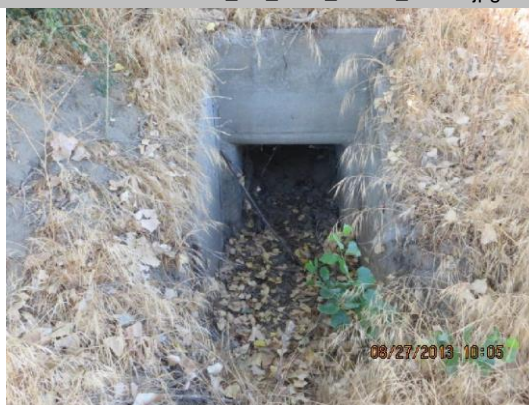
Photo 3 of 3 : UCIP\_SP\_2018\_18763\_31400.jpg

Concrete U-shaped headwall on LS toe.

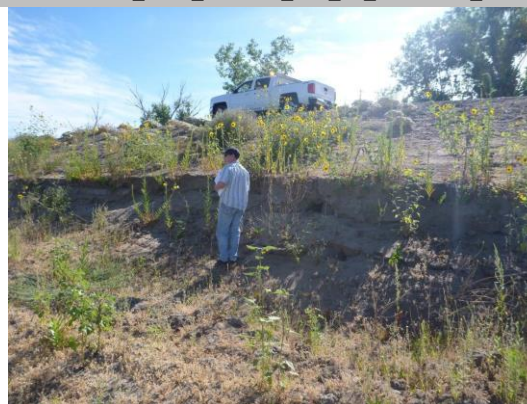
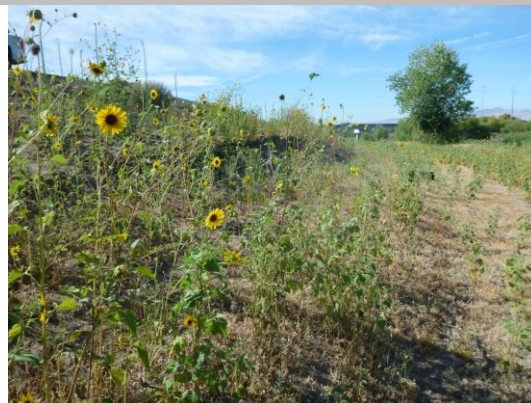
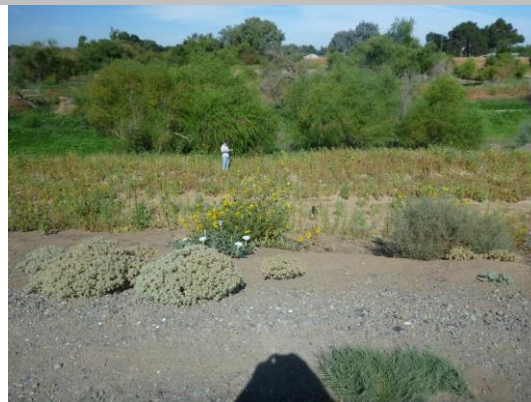
LM Start	3.26	Rating **	A/W	Issue No.	22
LM End	3.39	Issue Type +	Ma	Location *	
Category	Supplemental			GPS Latitude/Longitude	
				Start	End
Item	2017 Storm Damage			37.679100 °	37.677800 °
				-121.262600 °	-121.264400 °
DWR ID	DWR_RD2064_01_f_2017_22				
Comment Code					
Inspector Comment					
Levee Evaluation Comments					
Description:Erosion from high water flows caused erosion scarps from 12" to 30" in height. The area of damage is approximately 400 feet in length.					
Site ID No:582					
Site Designation:LMA-488					
Repair Type: Erosion					
Rating:Serious					
Field Date:8/14/2017					
Notes:

LM Start	3.26	Rating **	A/W	Issue No.	22 (cont)
LM End	3.39	Issue Type +	Ma	Location *	
Category	Supplemental			GPS Latitude/Longitude	
				Start	End
Item	2017 Storm Damage			37.679100°	37.677800°
				-121.262600°	-121.264400°
DWR ID	DWR_RD2064_01_f_2017_22				
Comment Code					
Inspector Comment					
Levee Evaluation Comments					
Description:Erosion from high water flows caused erosion scarps from 12" to 30" in height. The area of damage is approximately 400 feet in length.					
Site ID No:582					
Site Designation:LMA-488					
Repair Type: Erosion					
Rating:Serious					
Field Date:8/14/2017					
Notes:

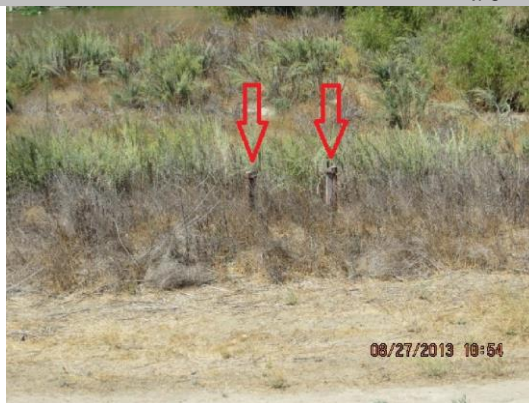
Photo 1 of 1 : UCIP\_SP\_2018\_22731\_38463.jpg

LM Start	3.46	Rating **	M	Issue No.	39
LM End	3.46	Issue Type +	En	Location *	
Category	Supplemental			GPS Latitude/Longitude	
				Start	End
Item	DWR UCIP Field Study			37.676751 °	37.676751 °
				-121.264193 °	-121.264193 °
DWR ID					
Comment Code					
Inspector Comment					
FS_ID:22731 DS_ID:20517 EP_NO: N/A Repair Type: Non-Urgent Crossing Status: Indicator Found UCIP Comments: Neet to verify status of pipeline. FIELD_STRUCT_DESC: Underground gas line crossing; depth through the levee and size unknown. Found possible sign posts on WS toe. FS Date: 8/27/2013

Possible sign posts on WS toe.

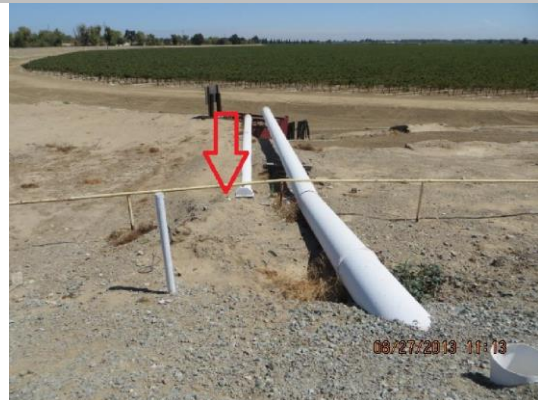
Photo 1 of 2 : UCIP\_SP\_2018\_22732\_38465.jpg

Pipe visible on LS toe.

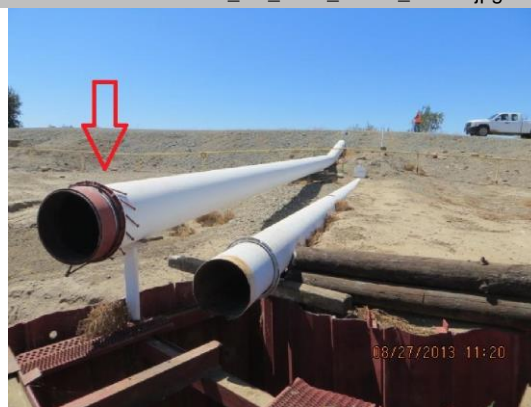
Photo 3 of 3 : UCIP\_SP\_2018\_22733\_38466.jpg

Pipe open at pump sump off LS toe.

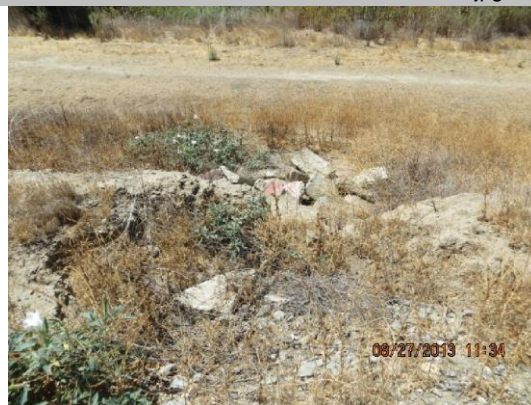
Photo 2 of 2 : UCIP\_SP\_2018\_19046\_31848.jpg

Concrete rubble on WS slope possible indicator of abandoned pipe location.

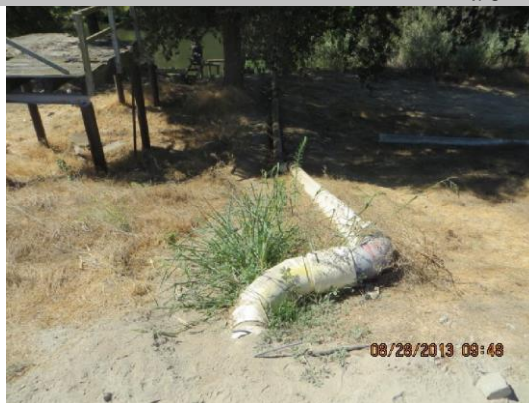
Photo 2 of 3 : UCIP\_SP\_2018\_44653\_37714.jpg

Pipe visible on WS shoulder/slope.

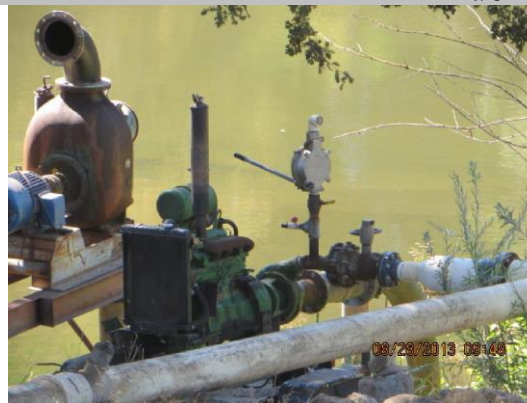
Photo 3 of 3 : UCIP\_SP\_2018\_44653\_37713.jpg

Portable pump on WS berm.

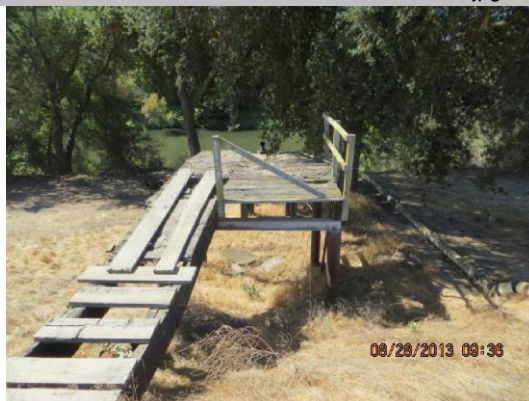
Photo 2 of 3 : UCIP\_SP\_2018\_51385\_31891.jpg

Deteriorated wooded pump platform on WS shoulder.

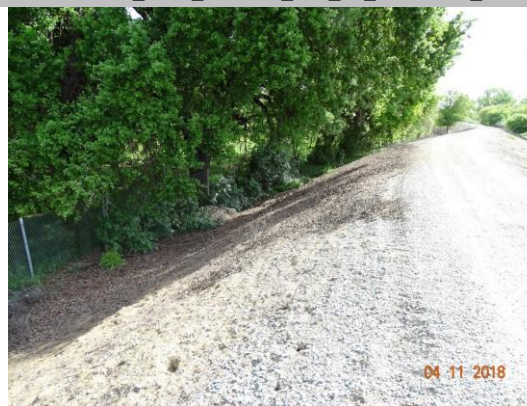
Photo 1 of 1 : SP\_2018\_RD2064\_314\_19\_20180411\_00069.jpg

Landside vegetation along fence should be reduced to allow inspection and access to slope and toe.

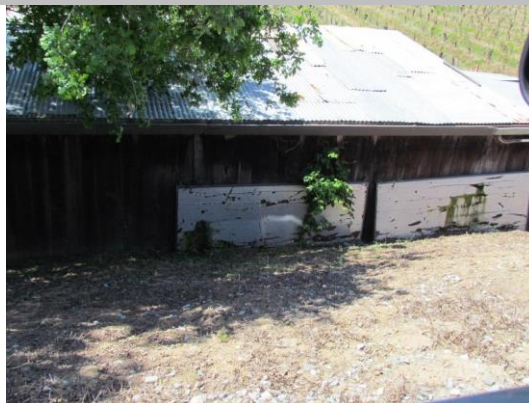
Photo 1 of 1 : SP\_2018\_RD2064\_314\_17\_20180329\_00001.jpg

RD 2064 looking upstream from levee mile 1.96 landside, building within the easement.

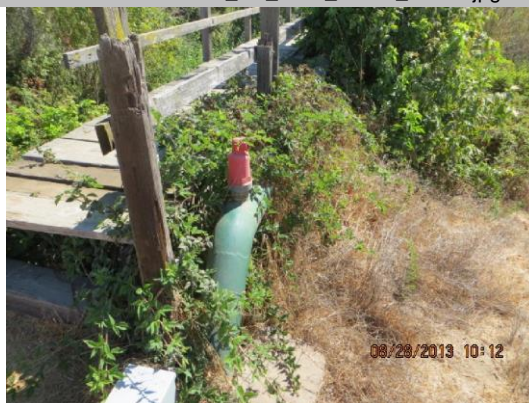
Photo 1 of 3 : UCIP\_SP\_2018\_22095\_37722.jpg

Pipe and vent visible on WS shoulder at wooden walkway.

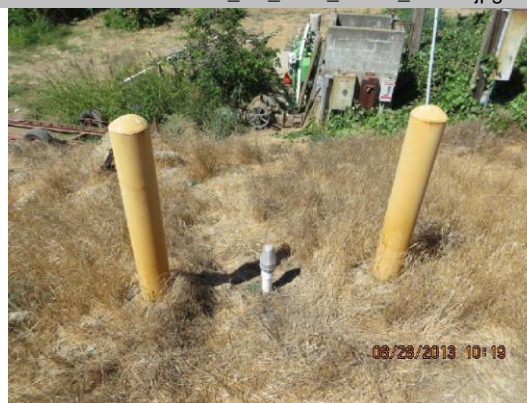
Photo 2 of 3 : UCIP\_SP\_2018\_22095\_37721.jpg

Vent on LS shoulder.

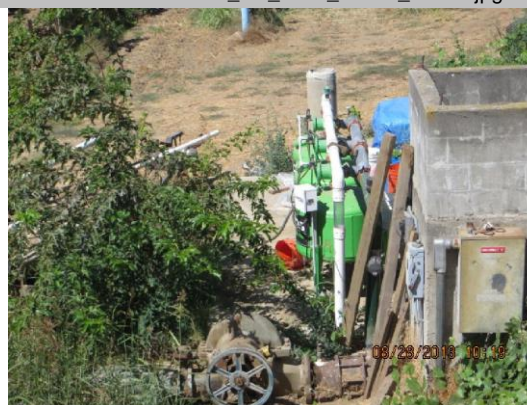
Photo 3 of 3 : UCIP\_SP\_2018\_22095\_37720.jpg

Filterplant visible on LS toe.

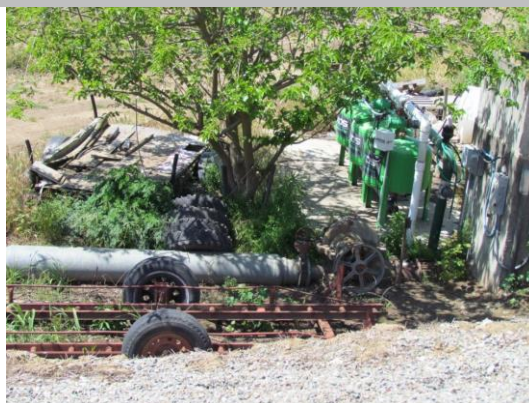
Photo 2 of 2 : SP\_2018\_RD2064\_314\_23\_20180329\_00006.jpg

RD 2064 Landside looking upstream from levee mile 1.97 more equipment and other materials within the easement.

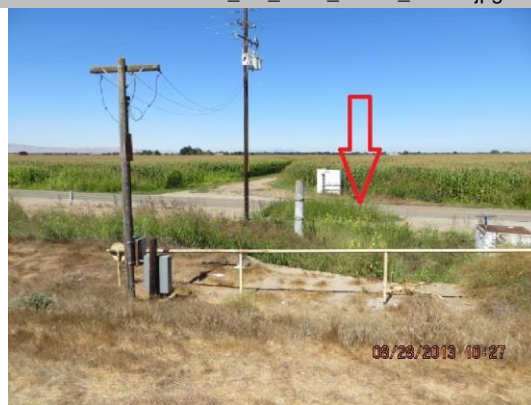
Photo 2 of 3 : UCIP\_SP\_2018\_19086\_31953.jpg

Wet area next to roadway off LS toe may indicate a leak. Power pole and meter on LS toe.

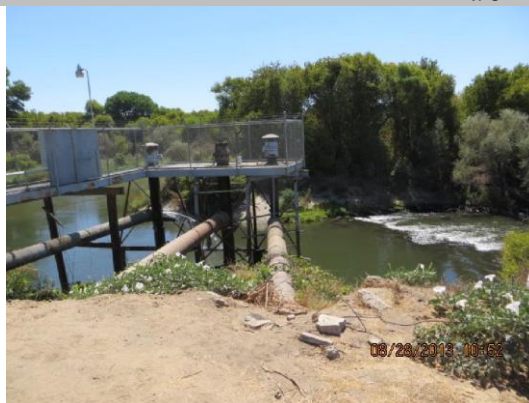
Photo 1 of 3 : UCIP\_SP\_2018\_41075\_31963.jpg

Pipe and pump visible on WS berm.

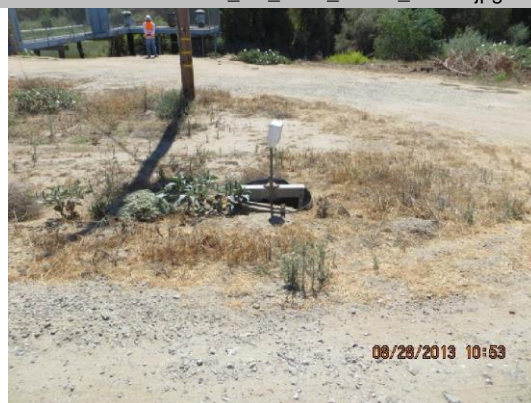
Photo 2 of 3 : UCIP\_SP\_2018\_41075\_31962.jpg

Slide gate in 36-inch CMP riser on WS slope.

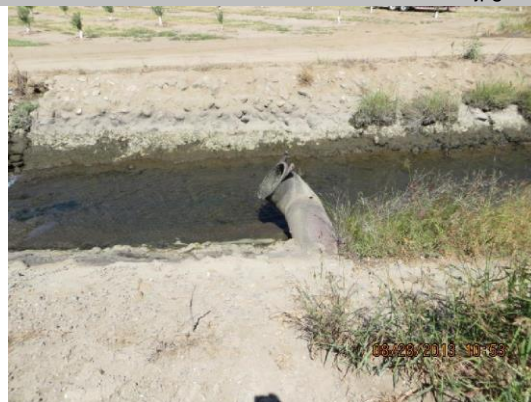
Photo 3 of 3 : UCIP\_SP\_2018\_41075\_31961.jpg

Pipe with missing flapgate on LS at concrete ditch.

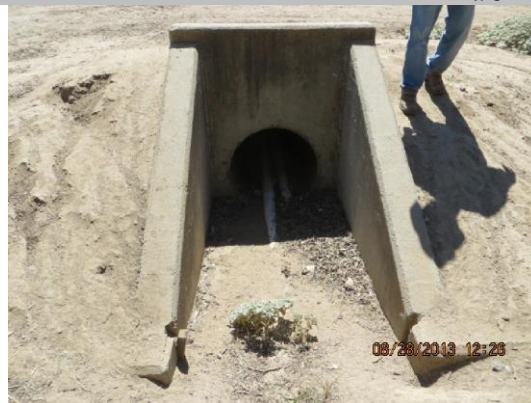
Photo 1 of 3 : UCIP\_SP\_2018\_22108\_37739.jpg

PVC pipe at right inside stormdrain on LS toe.

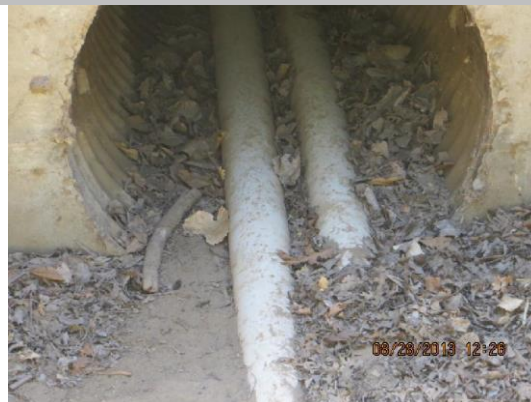
Photo 2 of 3 : UCIP\_SP\_2018\_22108\_37738.jpg

PVC pipe at right inside stormdrain on LS toe.

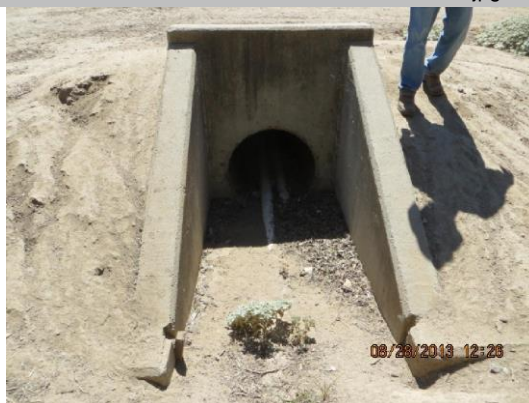
Photo 1 of 3 : UCIP\_SP\_2018\_22109\_37742.jpg

PVC conduit at left on LS toe.

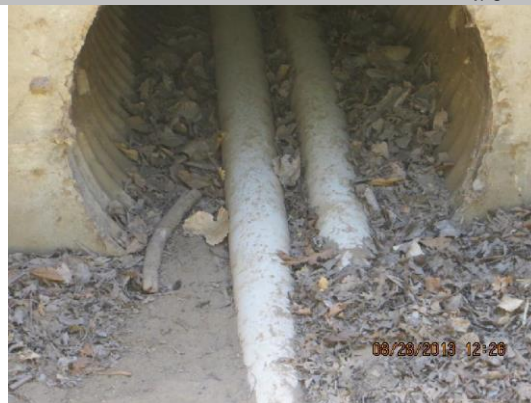
Photo 2 of 3 : UCIP\_SP\_2018\_22109\_37741.jpg

PVC conduit at left on LS toe.

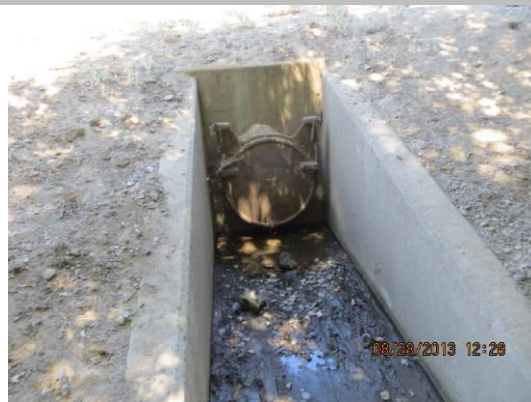
Photo 3 of 3 : UCIP\_SP\_2018\_22109\_37740.jpg

Evidence of discharge from PVC on WS toe.

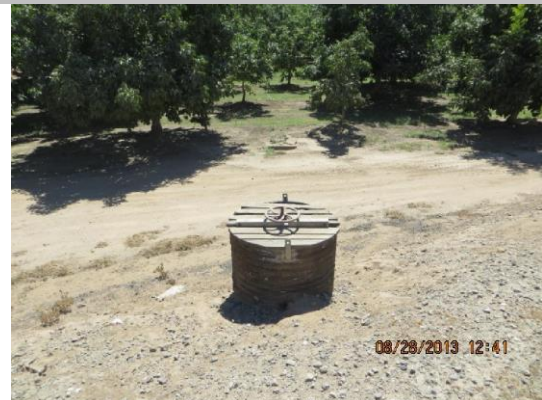
Photo 1 of 2 : UCIP\_SP\_2018\_19145\_32126.jpg

Slide gate in CMP riser on WS slope

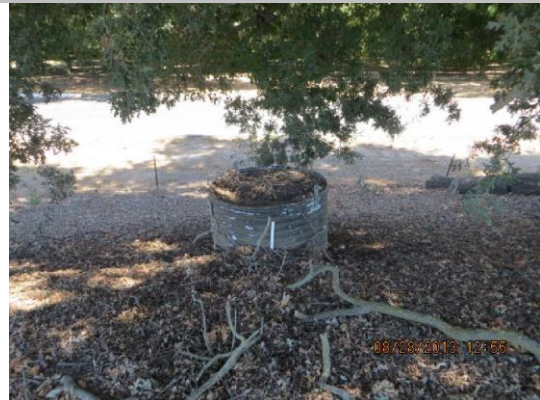
Photo 1 of 1 : UCIP\_SP\_2018\_19146\_32127.jpg

CMP riser for slide gate filled with soil.
